# PERFORMANCE OF WASTE ROCK COVERS – RUM JUNGLE

**G.F. Taylor, A. Spain, A. Nefiodovas  
J. Bennett, G. Timms, V. Kuznetsov**

# Mining Activities at Rum Jungle

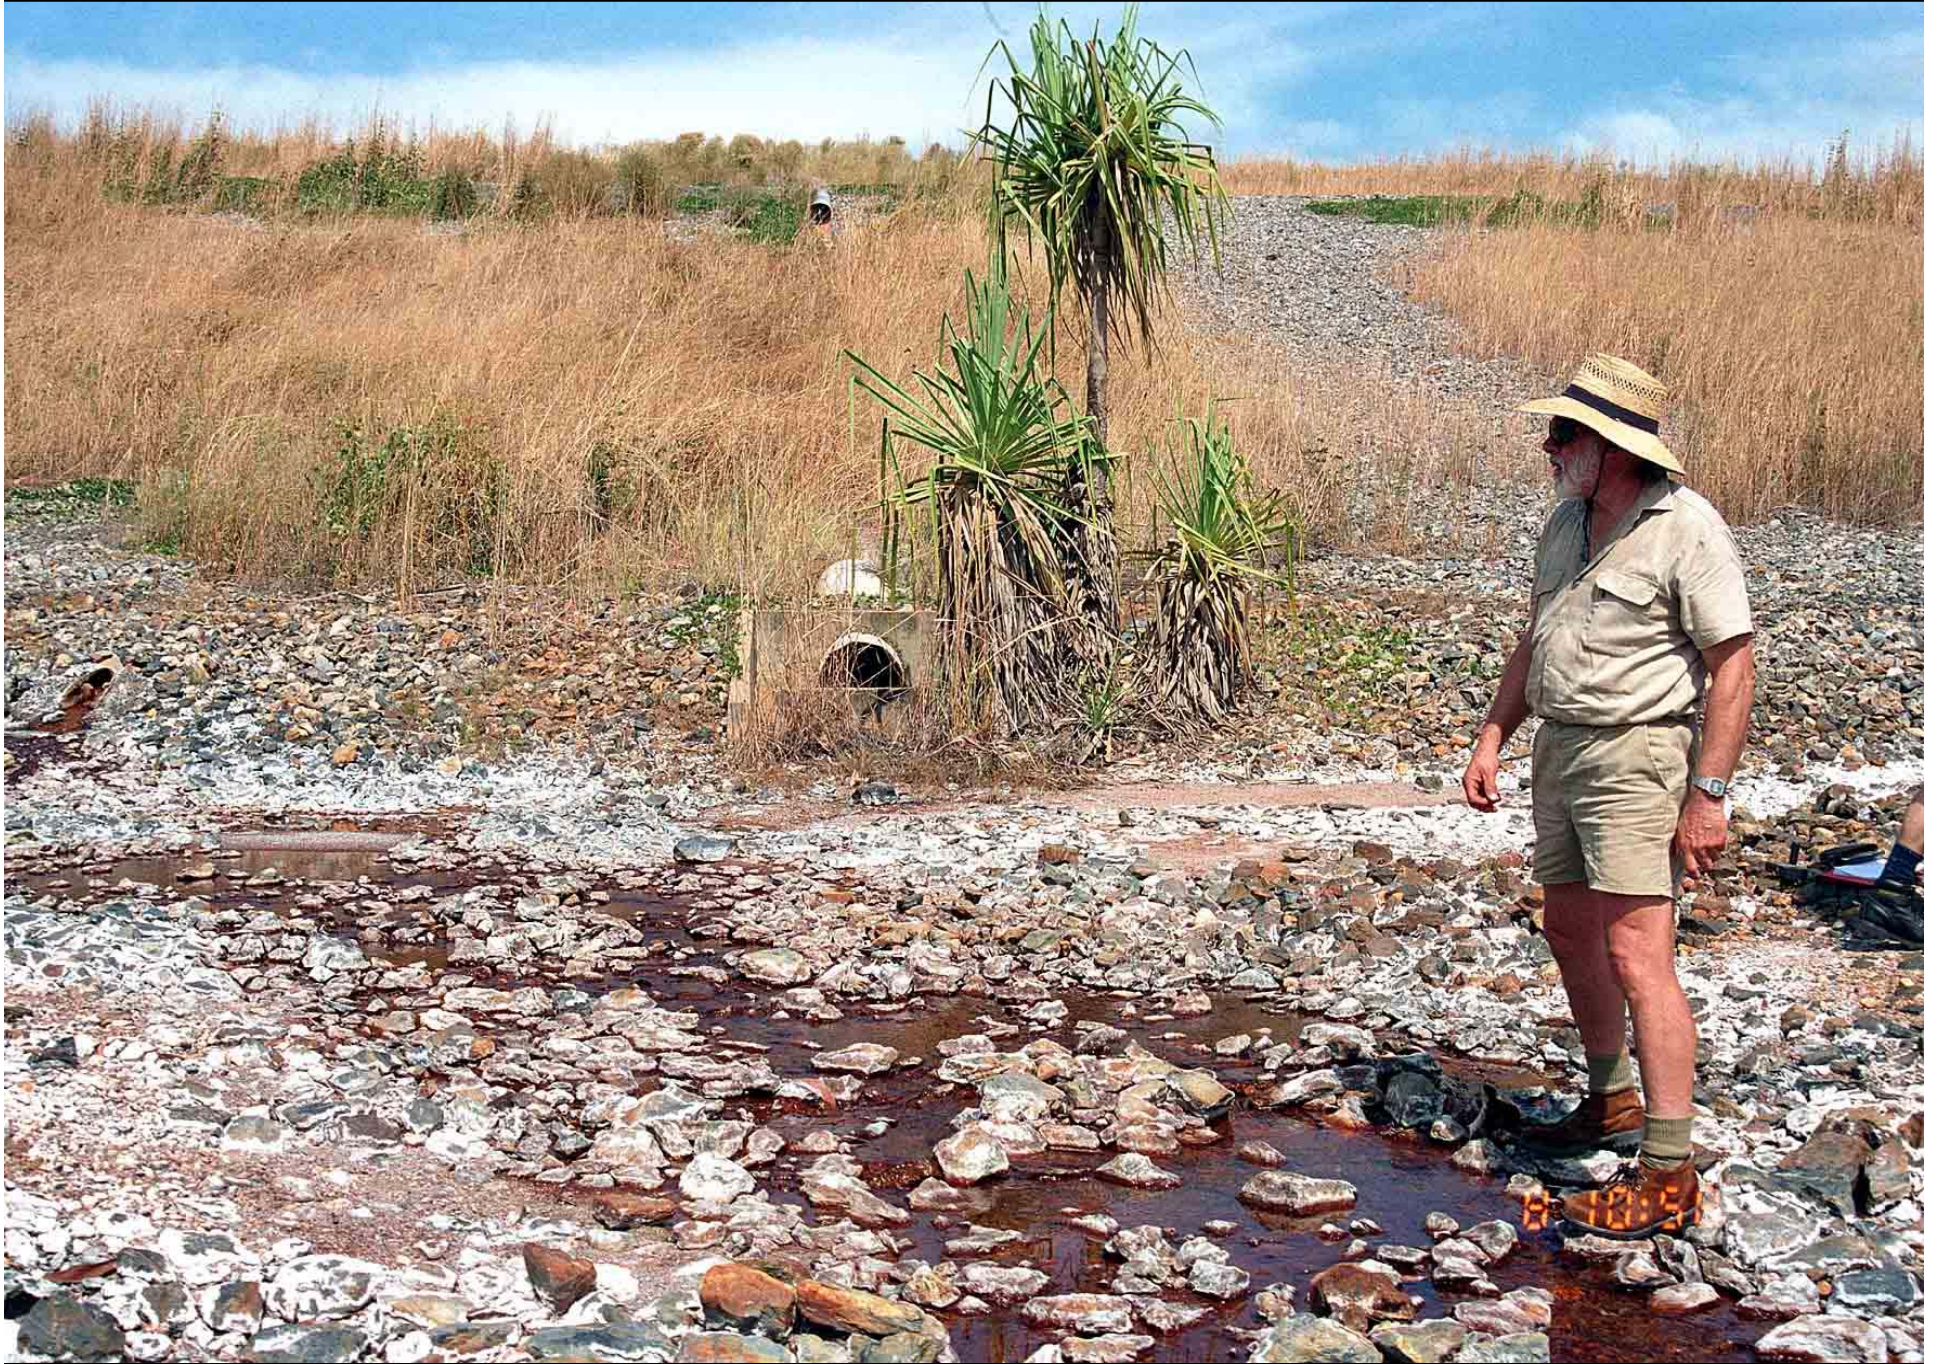
# WHITE'S OVERBURDEN HEAP

7.1 mt ; 26.4 ha ;  $4 \times 10^6 \text{ m}^3$

Consists of shales and slates  
with minor dolomite

Main sulfide is pyrite

IOR =  $1.3 \times 10^{-8} \text{ kg (O}_2\text{)m}^{-3} \text{ s}^{-1}$

Left for 26-30 years prior to covering

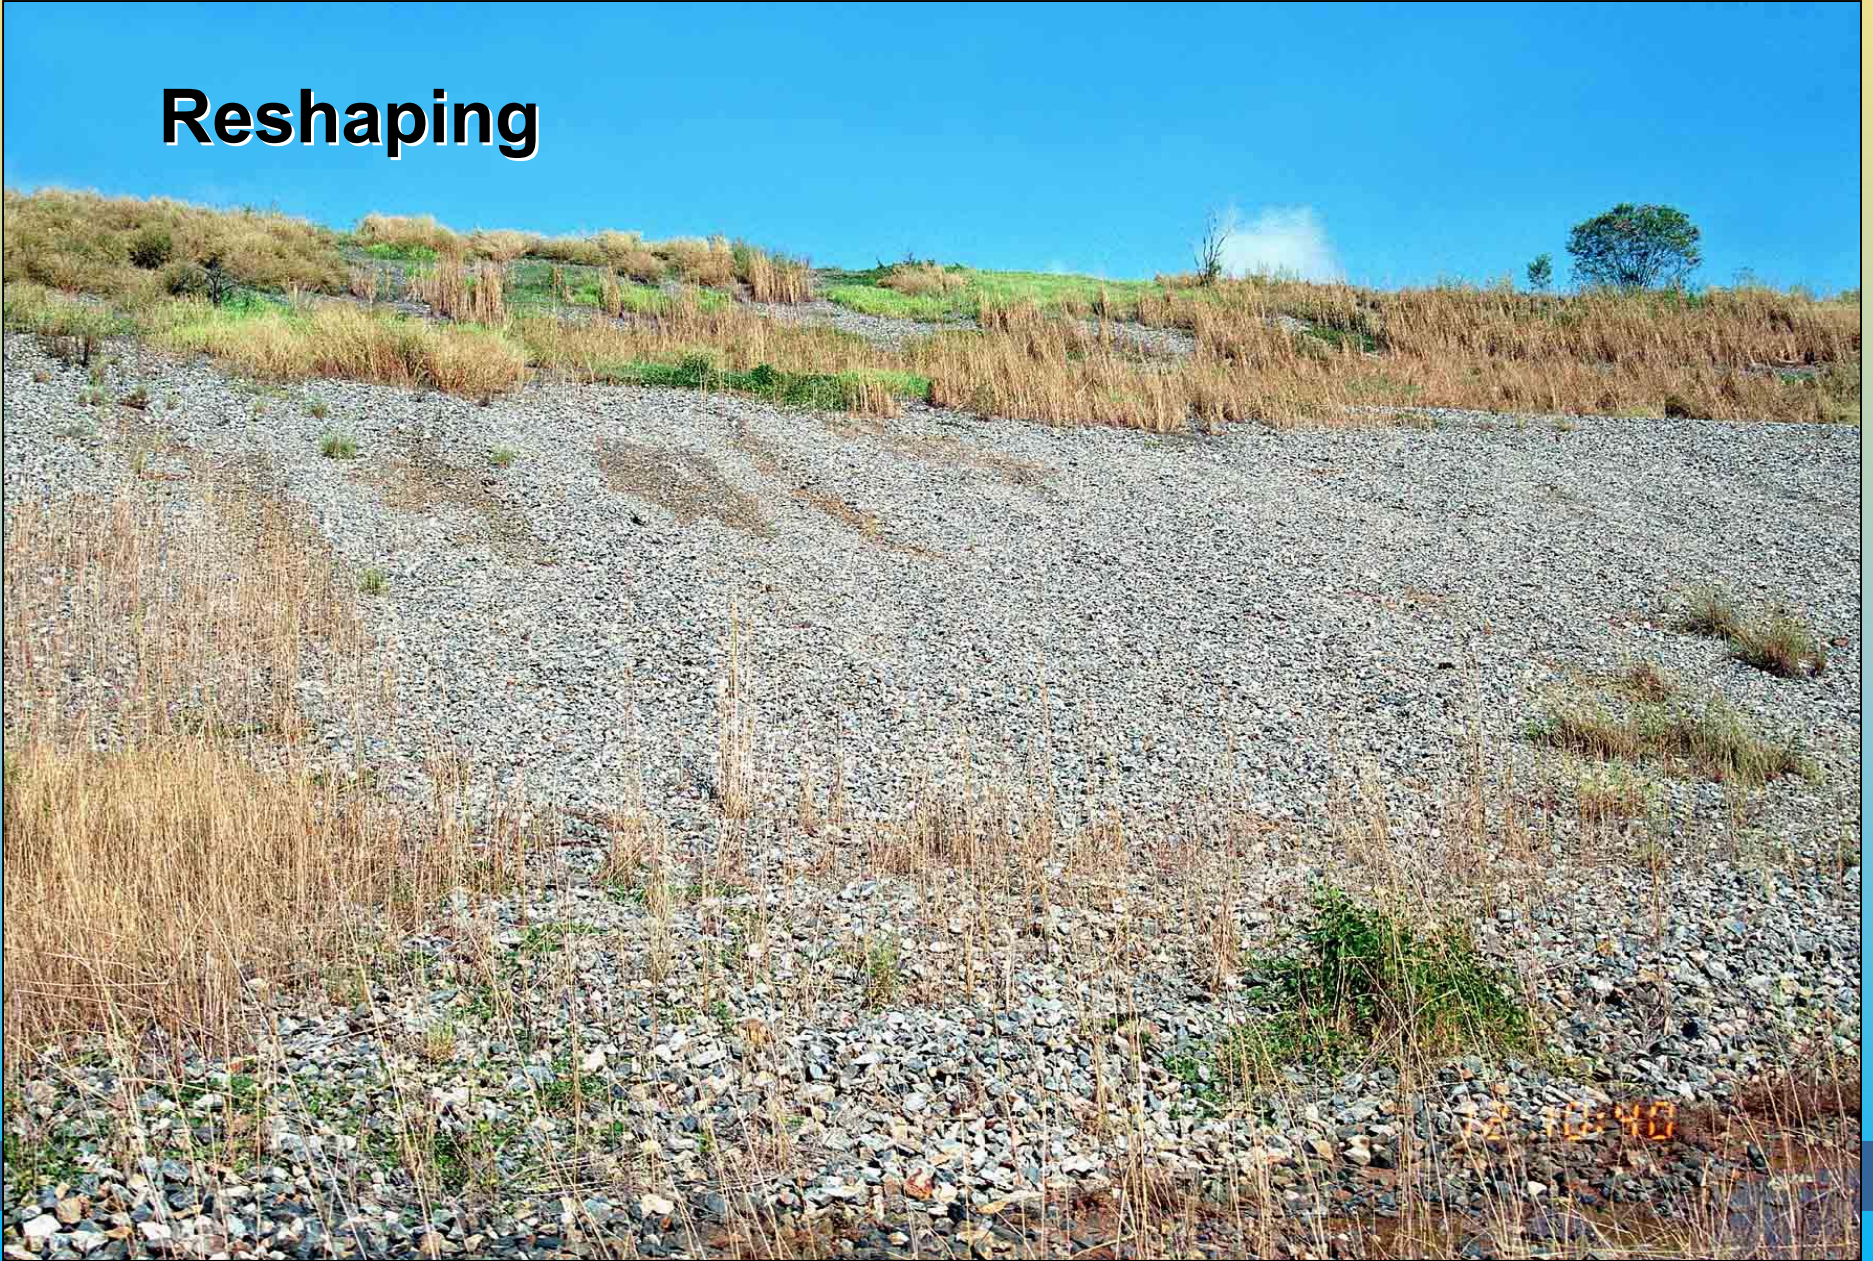
## Reshaping

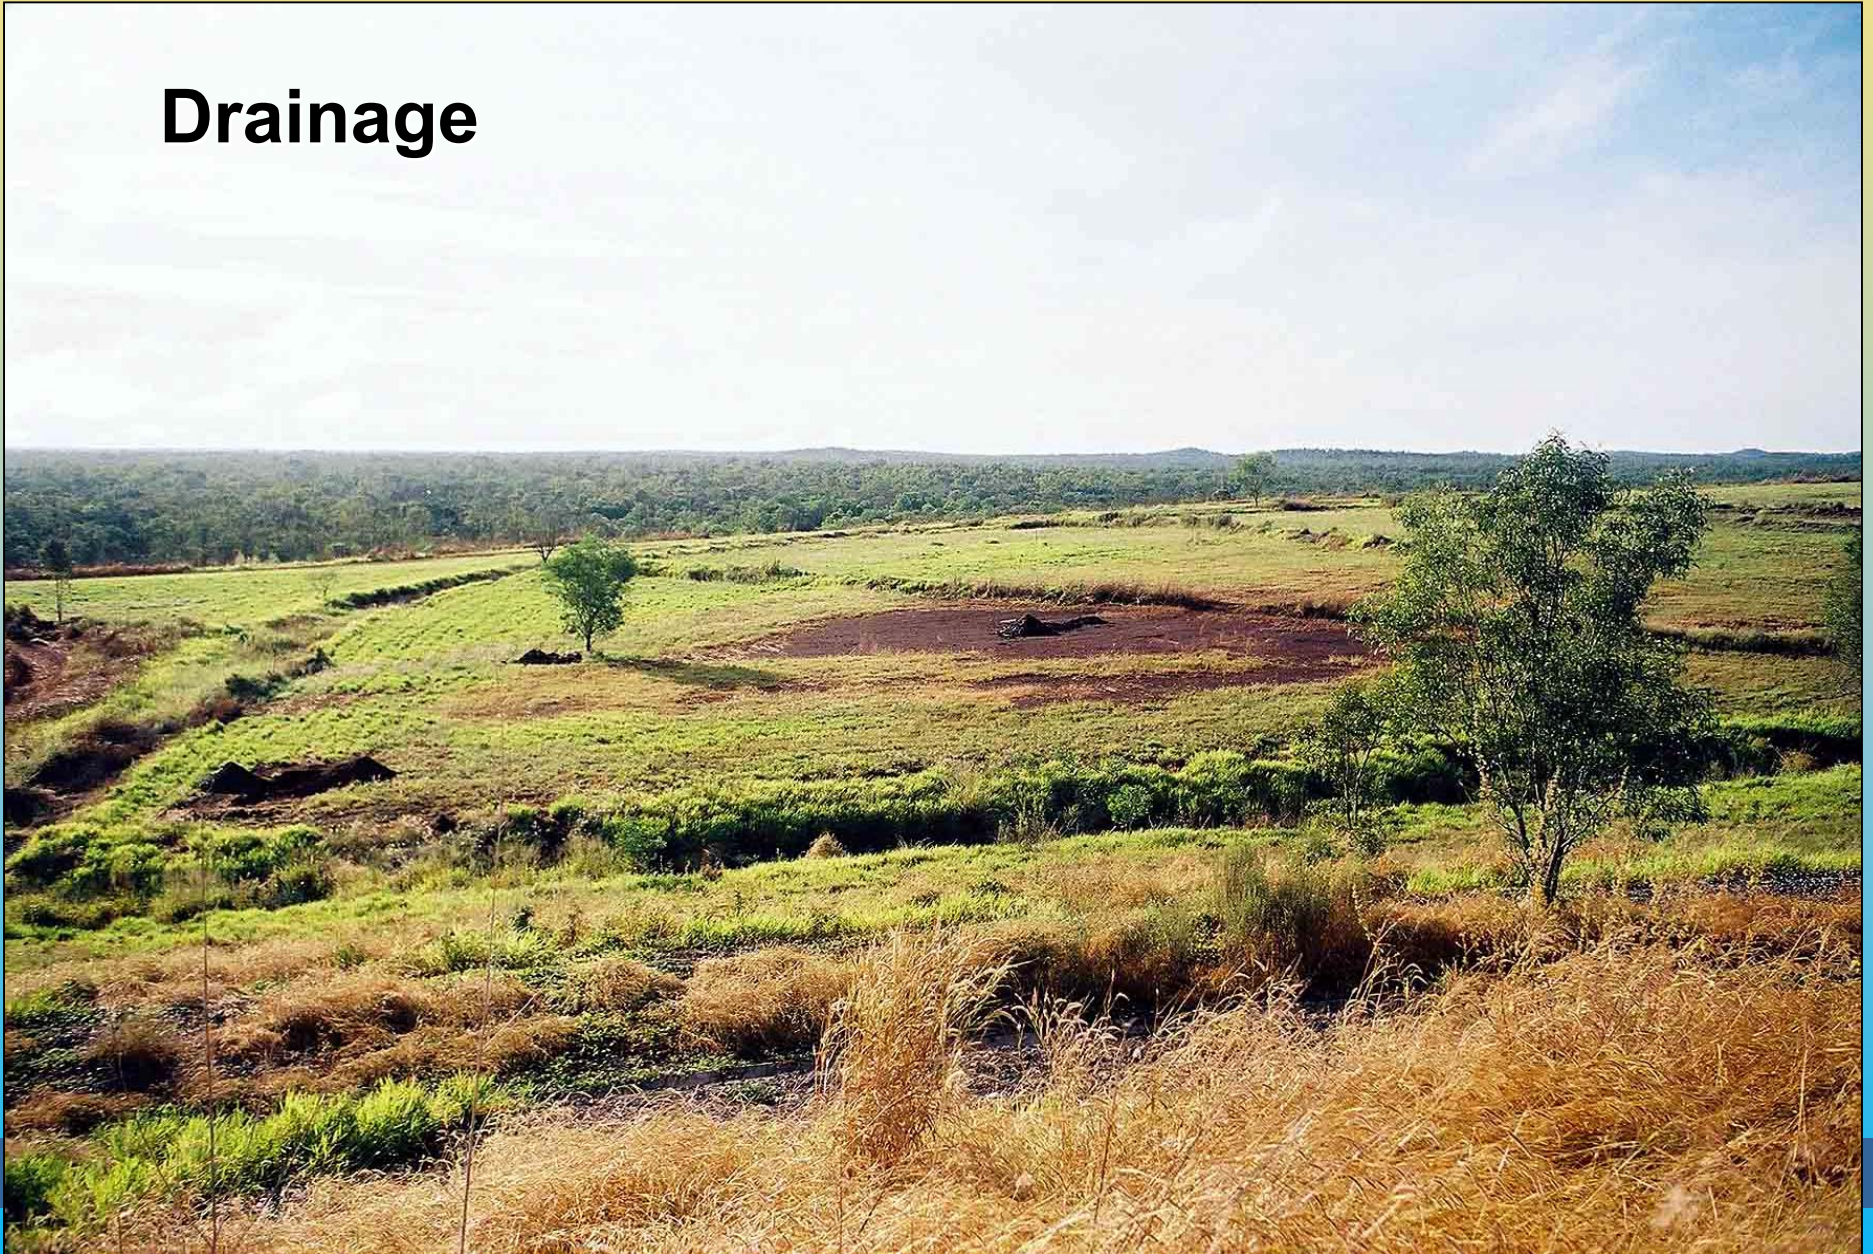
## Drainage

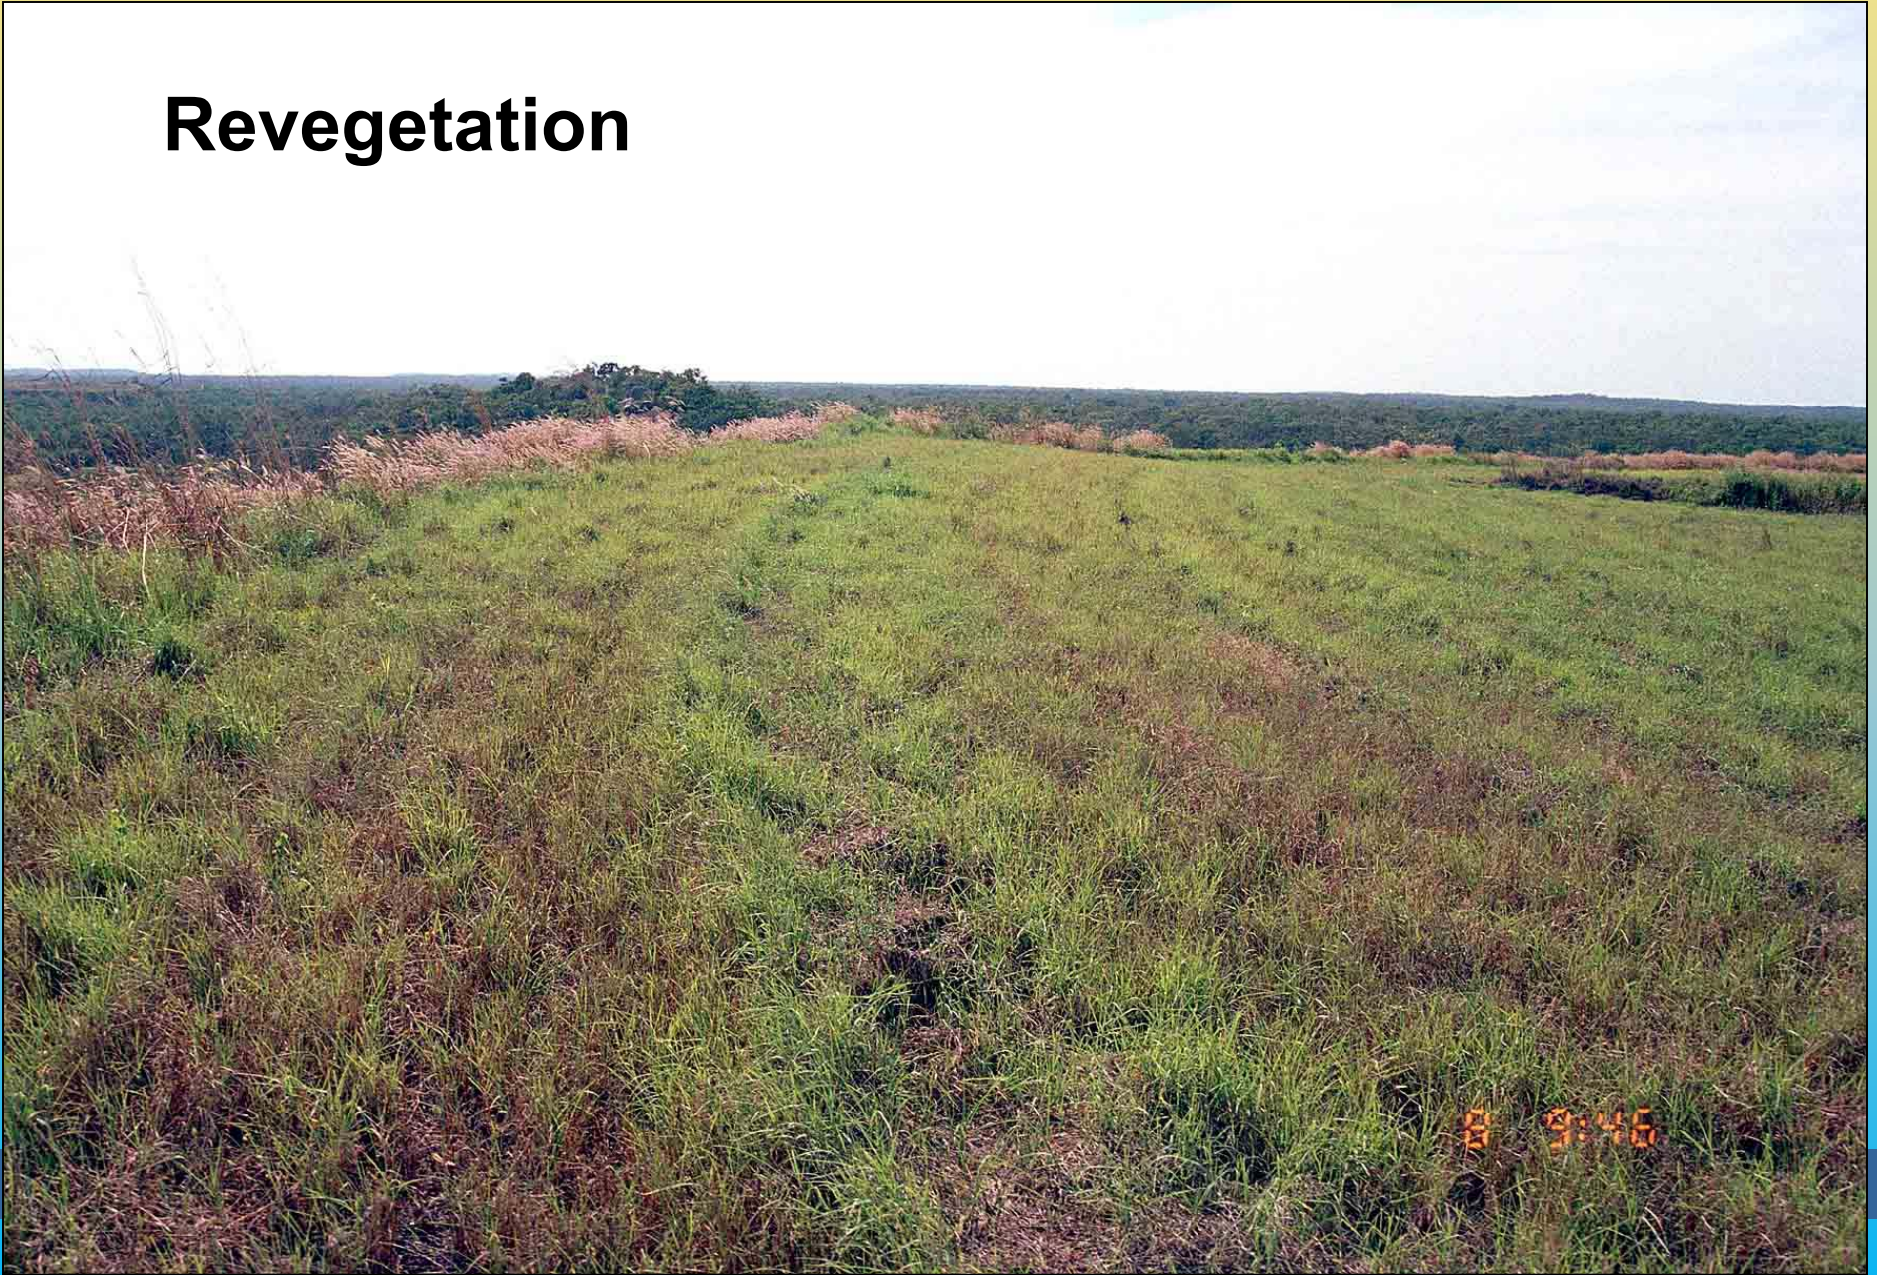
## Revegetation

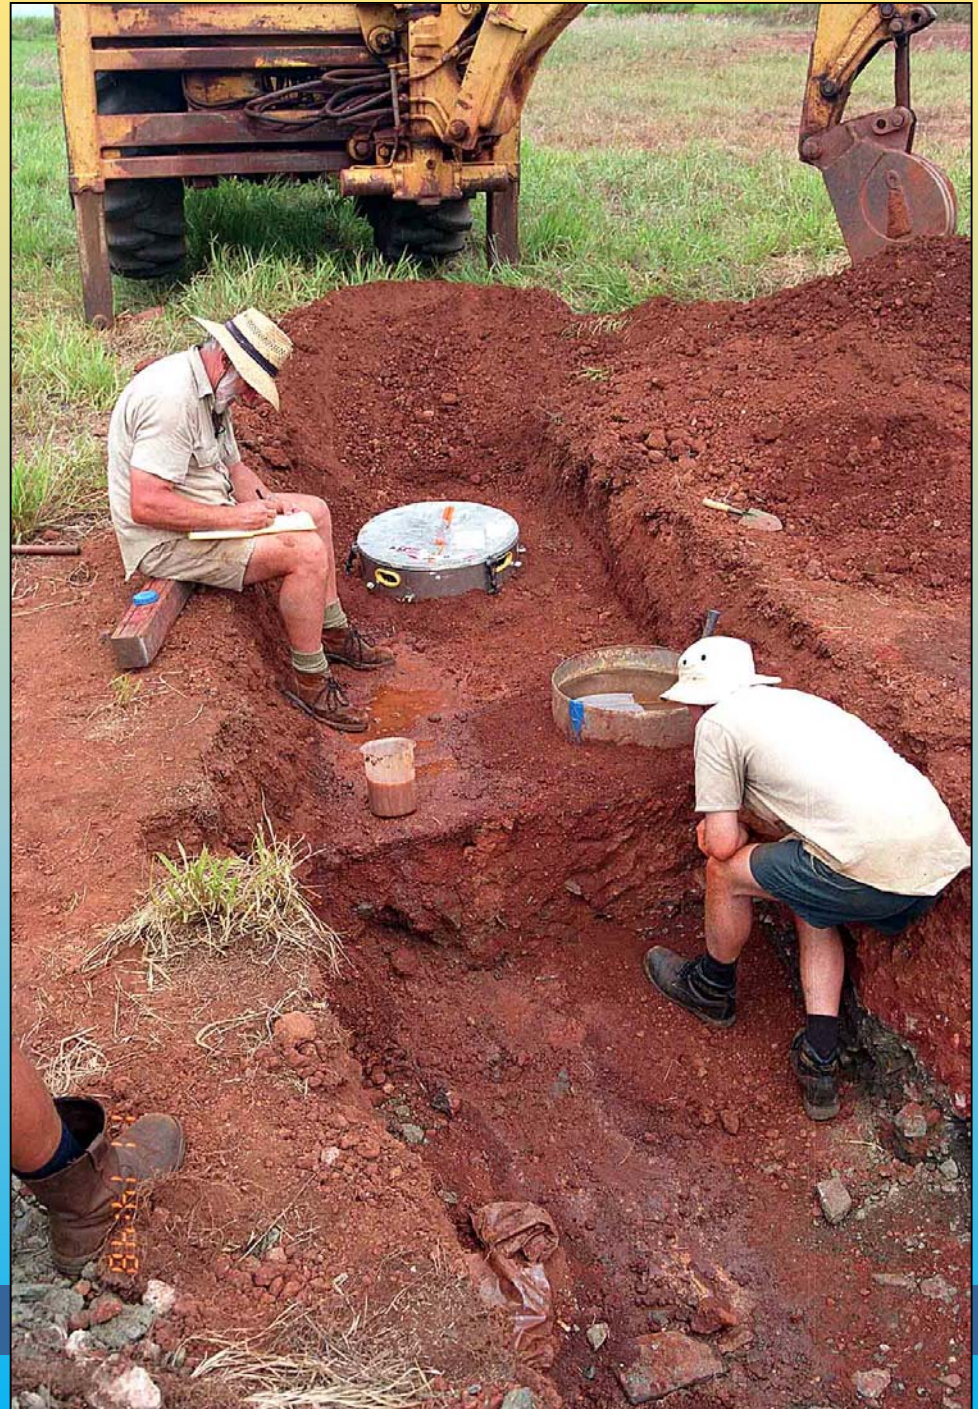
## Field tests

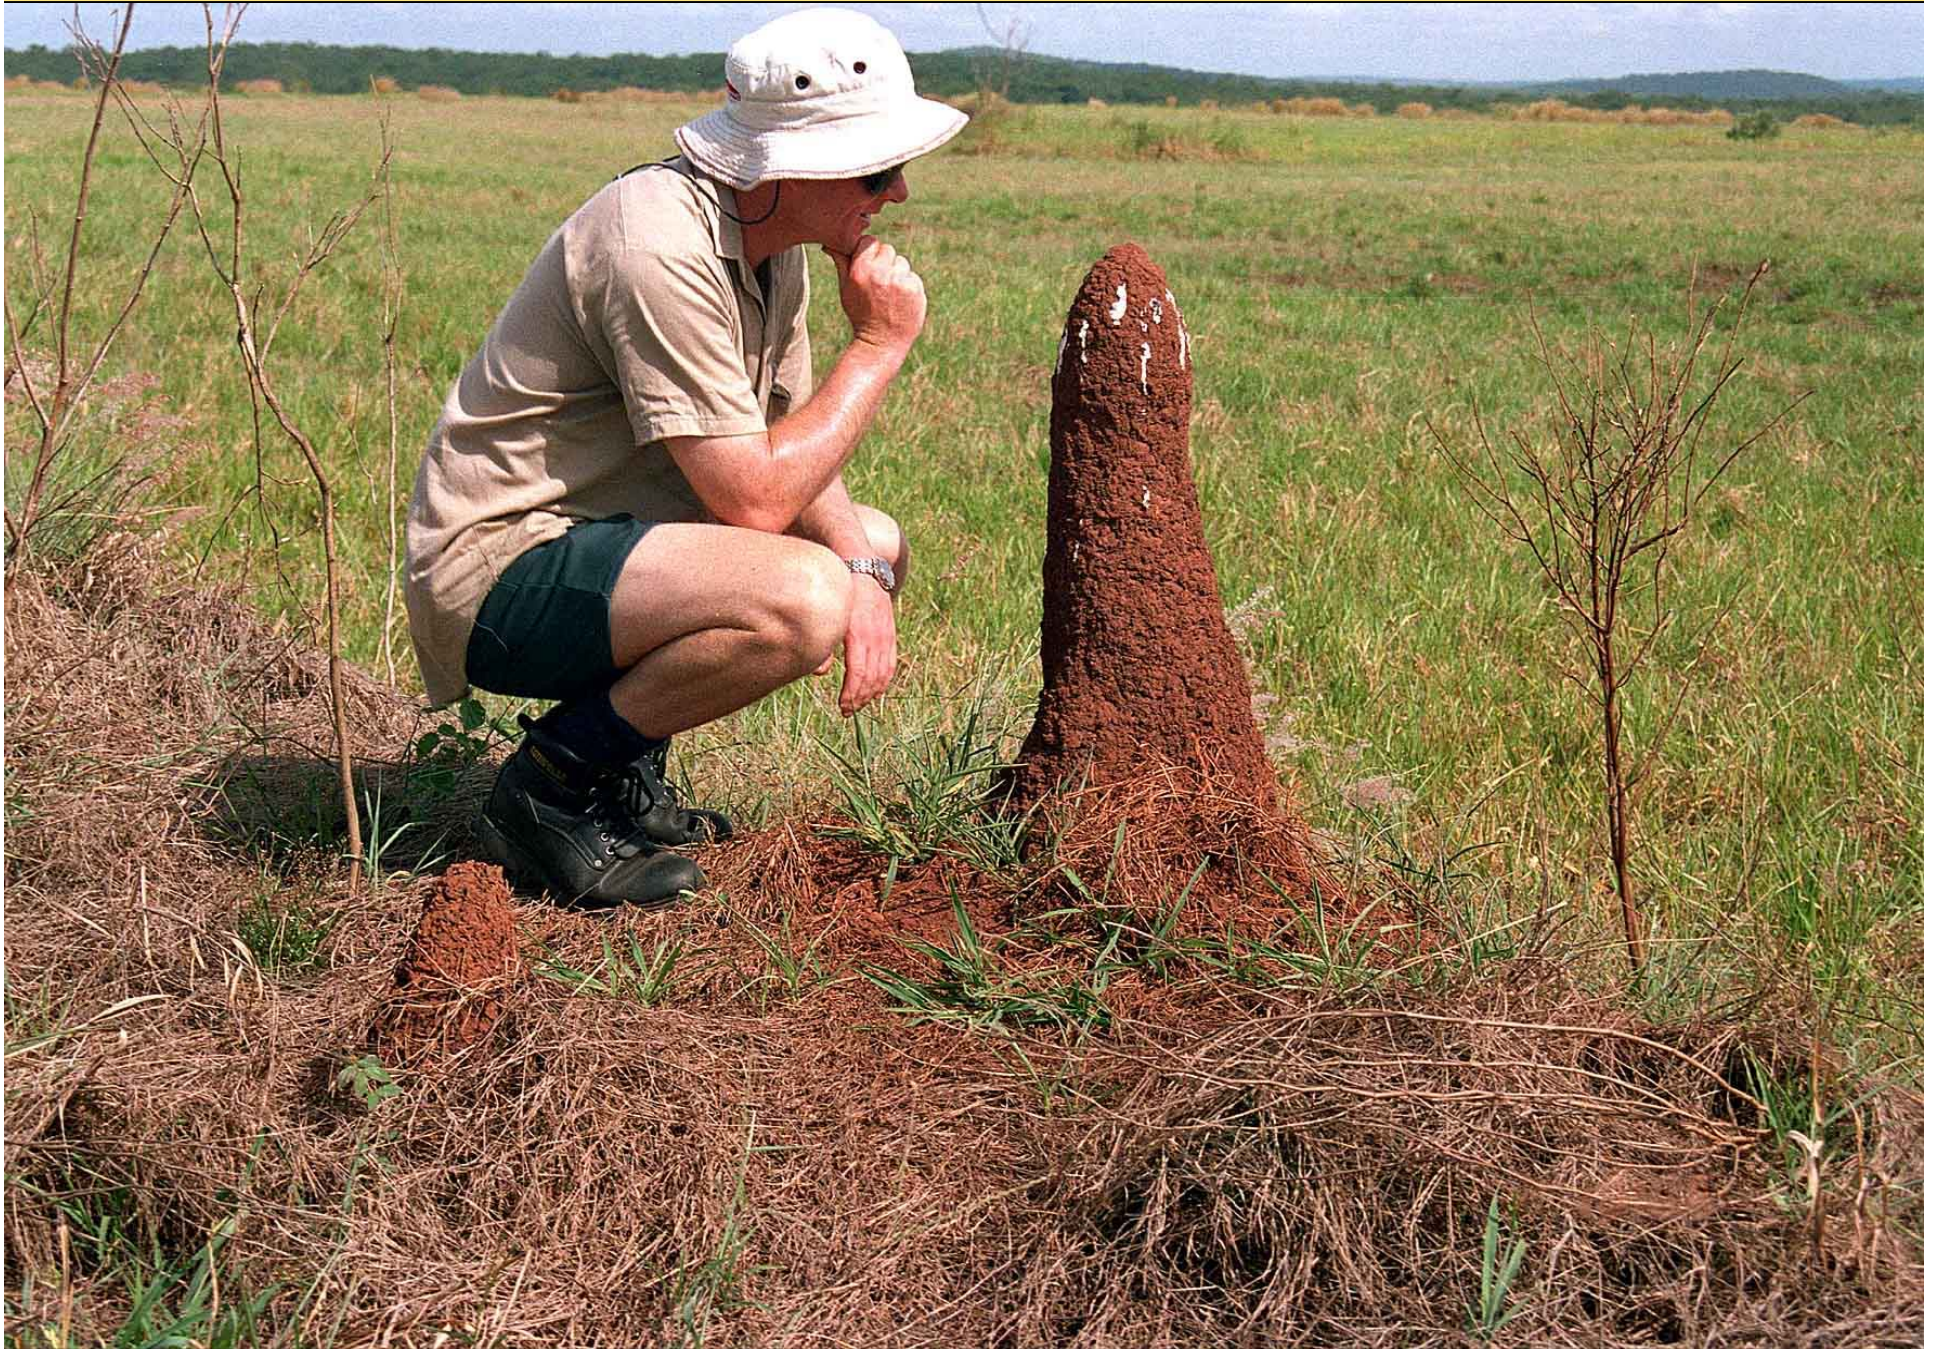
# **Biological changes :**

**Root penetration into waste rock**

**Termite / ant galleries**

**Both have increased permeability**
